Menkaure Valley Temple

The Great Pyramid Temple Project

Menkaure Valley Temple Season 2020

Volume 21 Numbers 1 & 2 Spring–Fall 2020

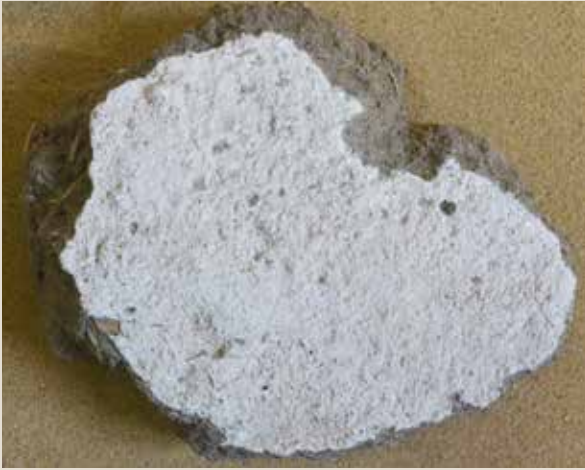
PL153. From KRO, thick pure white paint applied over grayish-brown plaster with cut straw and pebbles. The surface is rough flat alluvial mud, with tiny cavities in it. In contrast to other white paint used at Giza, this one is especially white, probably because it contains a high percentage of gypsum.

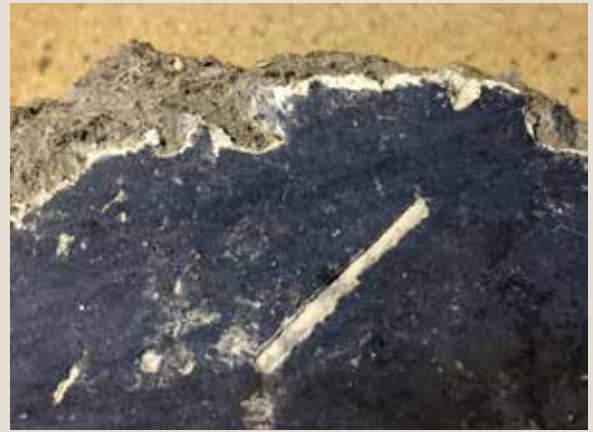
PL133. From KRO, very dark gray plaster applied on white plaster, over grayish-brown mud plaster. The very smooth flat surface shows that it was very carefully made. Many parallel horizontal lines on the surface suggest plastering using a float. The plaster contains many tiny black quartz pebbles, making the surface glitter.

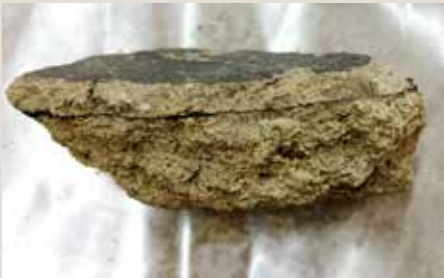
Plaster repair. This is one of only two examples of wall plaster that had been repaired. A layer of black-painted plaster was applied over an older layer of black-painted plaster. Both examples had been applied over mud plaster.

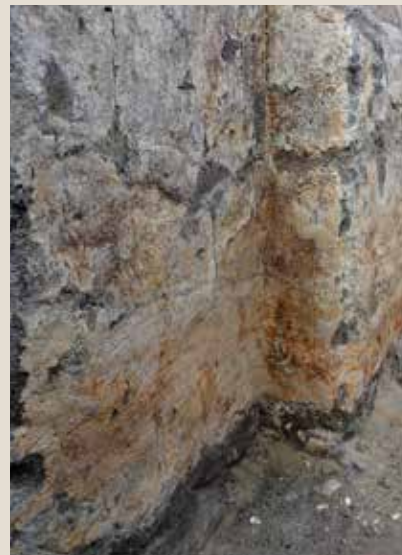
North face of wall, MVT. The rust red paint, although faded (perhaps due to water damage), has survived well on a wall in the MVT. It was applied over white paint, over grayish-brown alluvial mud plaster.

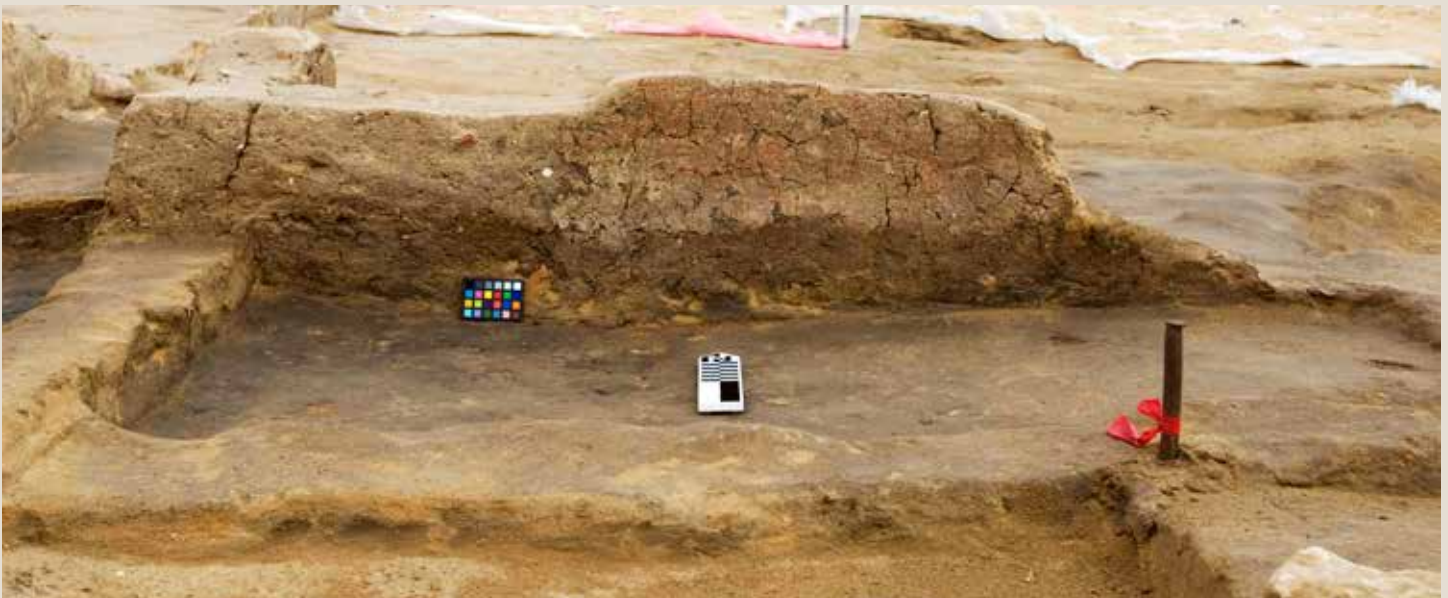
House 1 Bin. In a series of eight low bins in the southeast corner of House 1 at HeG, the plastering method is the same as elsewhere, except yellow marl clay plaster was applied over red, like a sandwich. The color is bright hematite red. One bin shown in photo by Y. Kawae.

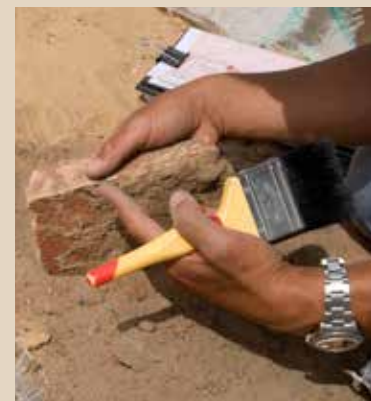
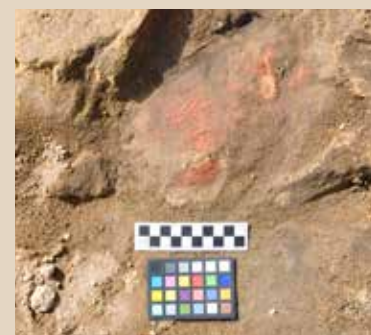
Below: The bedroom in House 1 at the HeG site. The map shows the location where an architrave probably spanned the pilasters. In the photo (center), fragments of the architrave lie on the floor, where they fell when it collapsed. Right top: Piece of architrave with red-painted plaster. Right bottom: Red-painted plaster from architrave in situ on the floor. Photos by Y. Kawae, except top right by M. Yahata.

A High Official's Bedroom. In House 1 (map, page 23), the home of a high official and a scribal workshop, excavators also found a large quantity of red-painted molded plaster on mud-brick, distributed in the southern part of the bedroom (photos, facing page).⁸ These probably formed an architrave spanning the pilasters, as in the official's reception hall in ES2, but in this case for a bed niche, which may have been a reuse of the space. The pieces bear very vivid red paint on a rough flat surface. The paint was applied over a very thin, light red plaster.

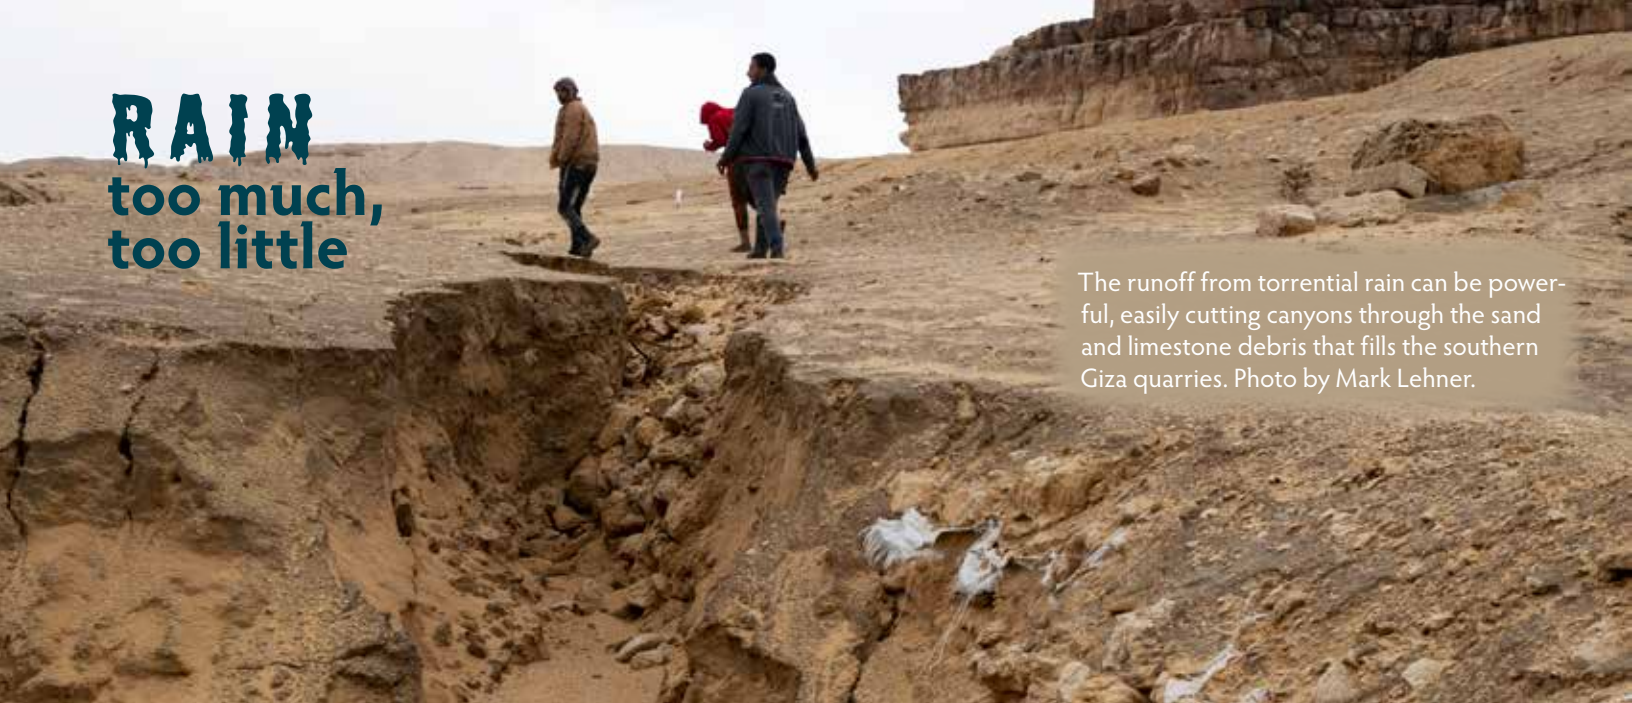
The runoff from torrential rain can be powerful, easily cutting canyons through the sand and limestone debris that fills the southern Giza quarries. Photo by Mark Lehner.

Water played a surprising, and unexpected, role throughout our Season 2020. On March 12 a violent two-day rainstorm struck Egypt and shut down Cairo—and our excavations in the Menkaure Valley Temple (MVT). It made us first-hand witnesses to the horrifying power of a “dragon storm,” a type of cyclone. After the skies finally cleared on March 14, we could see how torrential rains had ravaged the Giza Plateau. Just north of the MVT, runoff from high up on the plateau tore deep channels through the sand and limestone debris.

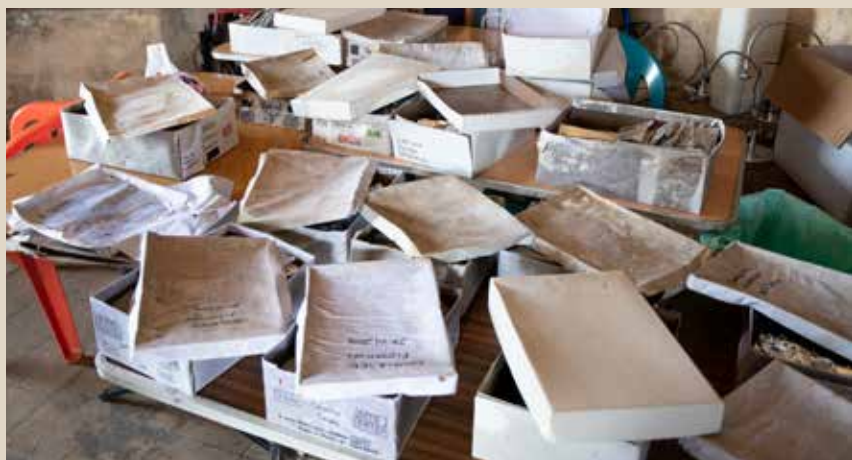
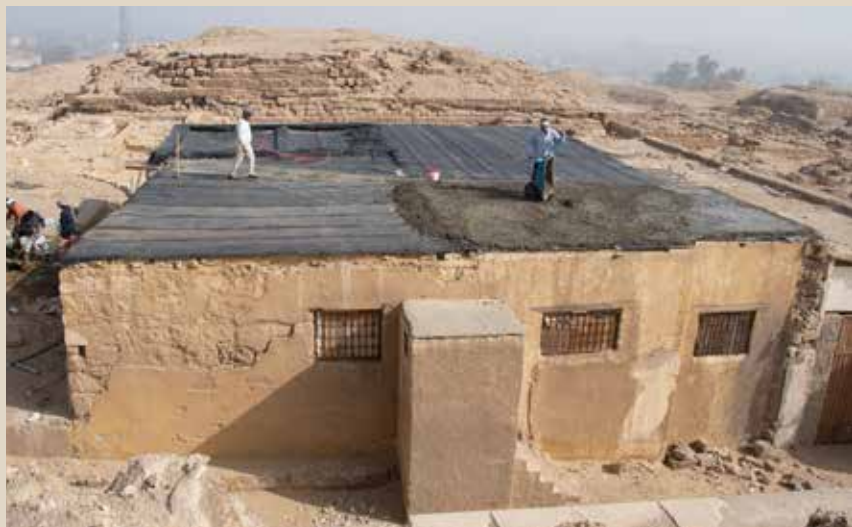
Above middle: Cartons containing archaeological materials spread out to dry. Bottom: Workers spread cement over the new heavy duty plastic that they laid to reinforce the roof. Photos by Mark Lehner.

The dragon storm did not spare our fieldwork and lab in a Ministry of Tourism and Antiquities Magazine store-room. The old roof could not stand up to the onslaught of two days of steady, hard rain. Water pooling on the roof eventually leaked through. The day after the storm ended, team members rushed in to rescue papers, equipment, and samples. They succeeded in drying everything that water seeping through the roof had touched, so in the end there was no damage, except to the roof, which we had to have repaired. At the end of March, workers spread heavy-duty plastic over the roof and covered it with cement.
